The Friends of the Pine Creek Grist Mill

Restoration Progress Report 102

May 18, 2019

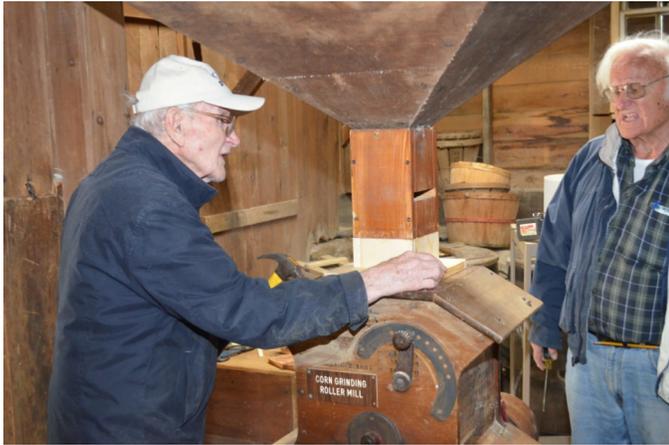
The first problem that had to be dealt with concerned the three roller corn mill. In the past a rubber coupling had been installed to connect the in-feed of the mill with the shelled corn bin that hangs from the ceiling above the mill. This winter the mice had eaten away a large part of the coupling spilling a lot of corn on the floor. Dick and Clarence Klauer built a new coupling out of wood that is more historic in appearance to the old rubber one. The new wooden one looks much better.

The Klauer brothers Dick and Clarence are working on restoring the in-feed on the corn mill. The old mouse eaten rubber connection has been replaced.

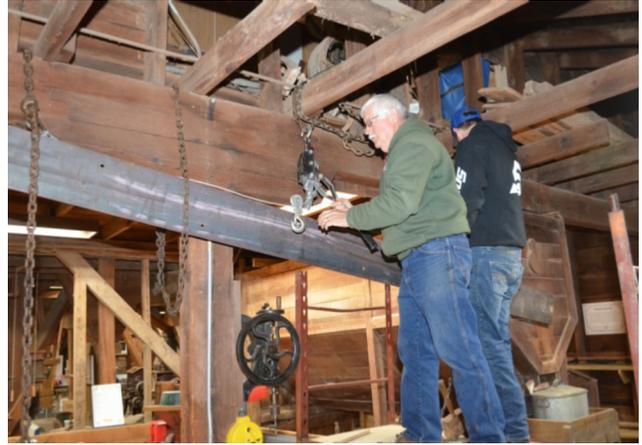
Next on the list was the installation of the steel reinforcing plate on the wood beam that is directly above the country store. The beam is 18' long and weighs 300 pounds, getting into position was not easy.

At right Dick Stoltenburg and the crew are lifting the steel reinforcing plate up to the wood beam. Note the chains hoisting gear.

We were fortunate to have assistance in installing the beam from park manager Jordan and his intern. Wood clips were installed on the wood beam along with safety chains to ensure that the steel plate could not fall during its installation. We used chain hoists to lift the plate up on the east end of the wood beam, then slid it horizontally along the wood clips north until it was in place on the west end.

The steel plate had pre-drilled holes in it for the bolts that attach it to the wood beam. Dick Stoltenburg drilled the deep holes in the beam, the bolts were installed and the job was done. We may decide to give the steel plate some cosmetic treatment at a later date.

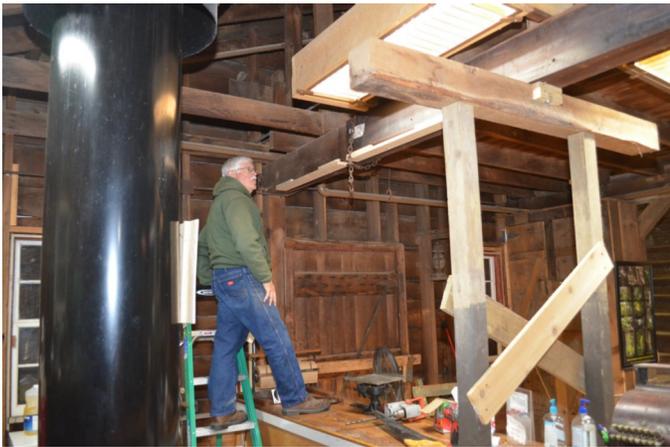
At this point the steel plate is almost in place. It is held against the wood beam by wood clips. Note the safety chains that prevent it from falling.

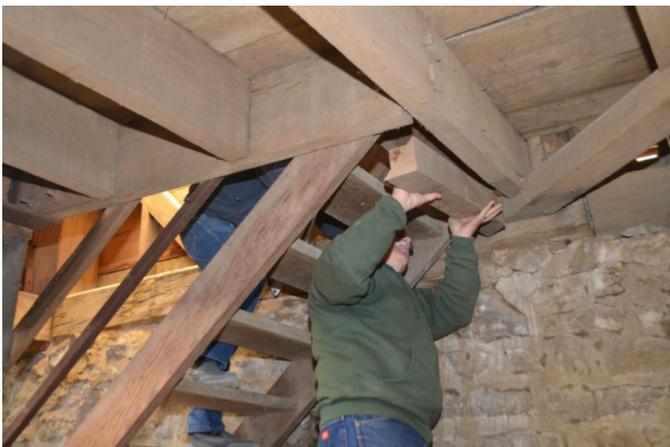
A new issue: Heather Shopa noticed that the basement stairs appeared to have sagged. On closer inspection we discovered that only two nails held the stairs in place. This did not surprise us as years ago the crew had discovered the same thing on the stairs to the second floor! Apparently the original builders of the mill had great faith in nails.

Above Dick and Clarence are test fitting the new support beam for the basement steps.

After some careful inspection we decided to add a reinforcing beam under the stairs that would be bolted to a floor joist. This involved some complex shaping of the new beam to ensure that it would fit under the stairs at the correct

angles. In other words it took a lot of try, cut and fit to get the new support in place. We were fortunate that we were able to fabricate the support beam out of an old piece of wood that perfectly matched the surrounding historic lumber.

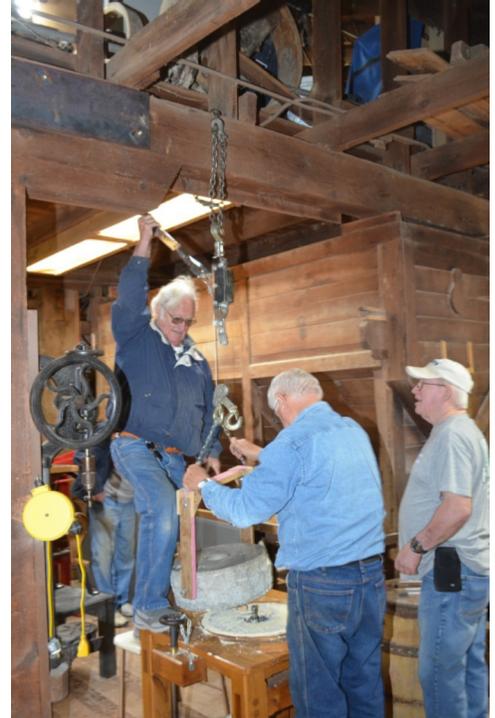
Sometimes things break in strange ways. As I inspected the mill one day I noticed a "do not use" sign on that kids favorite the mini-mill. On closer inspection I discovered that the wood runner stone bearing (located in the center of the bed stone) had fallen out. There is no apparent way that could have happened since the bearing fits very tightly, yet there it was on the base of the mill.

Dan Litwiler (on the right) is being shown how to use the hoisting fixture to lift the runner stone off of the mini-mill.

We hoisted the runner stone off using our lifting fixture and a come-a-long for safety. Once the runner was off some careful pounding with a mallet got the bearing back in place and the mill working again.
