Friends of the Pine Creek Grist Mill

Wildcat Den State Park, Muscatine, Iowa

Progress Report

Where we stand November 8, 2008

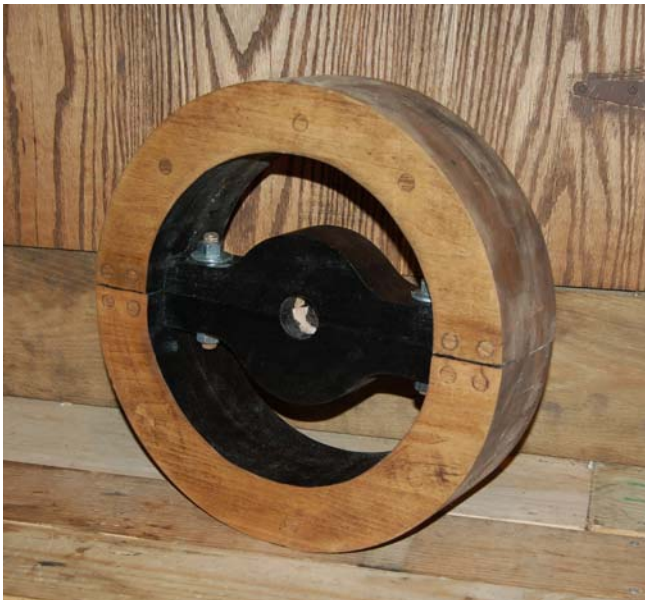
The pulley is a split type made in two pieces. It is designed to clamp around the shaft it drives. In the photo you can see two large bolts that hold the two halves together.

The outer cylindrical portion of the pulley is made from small curved sections of wood that were cut out with a band saw. They are laminated together with glue and secured with screws. The screw holes are recessed and plugged to conceal the screws. This basic pattern of construction can be used for larger pulleys as well.

With the steam engine turning at 1/4 of its original speed, we decided the engines Gardner flyball governor turned too slowly.

The engine's governor is mounted above the valve chest over the cylinder. The governor is driven by its own pulley that is offset from the engine's flywheel shaft. Because of this offset the governor has to be driven via a jackshaft that is mounted over the engine.

The simplest way to make the governor spin faster is make the diameter of the pulley that drives the governor larger. Seeing as we are considering going into the pulley business Scott Gibbs built a new split center pulley as an experiment. As you can see the pulley turned out very well.

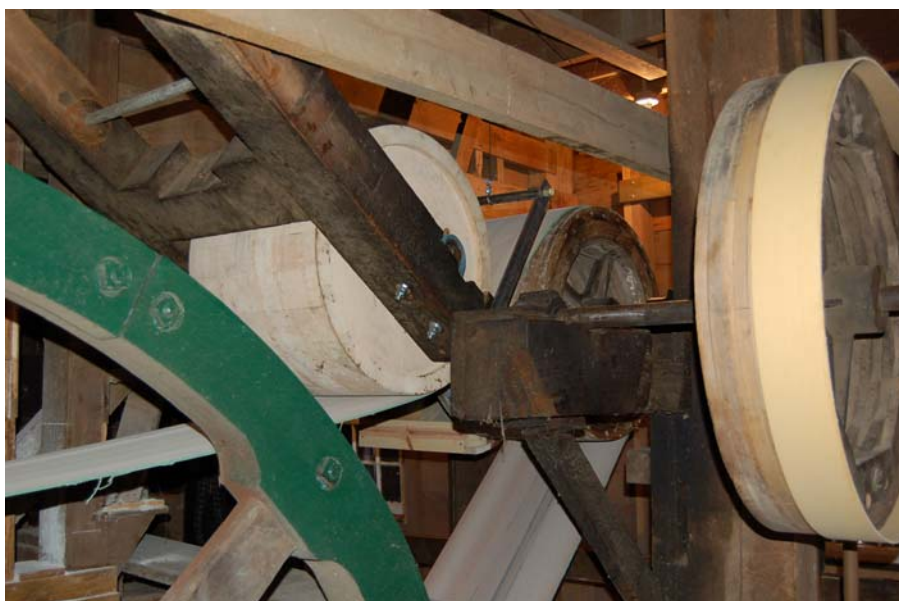
The new steam engine belt idler pulley that we turned on our new pulley machine can be seen here. The beams it is mounted on are called the "trapeze." A winch and cable control how tight the idler makes the engine belt.

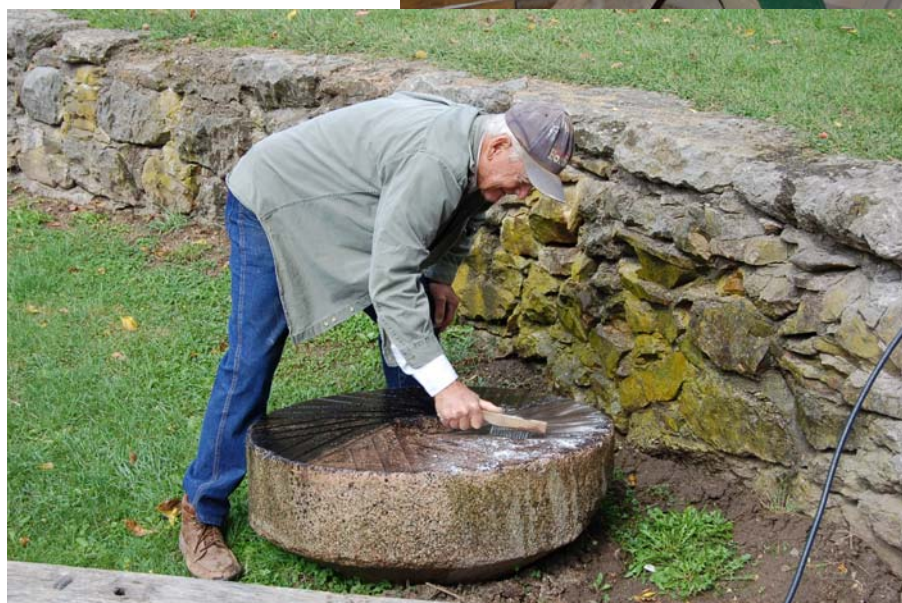
Joe Clark brought out his pressure washer and a lot of elbow grease to clean the millstone we have on exhibit outside the mill.

The millstones that were donated to the Friends last year are now on exhibit, one at the mill and one by the parking lot. Joe Clark brought his power washer out to the mill one Tuesday and cleaned the stone by the mill. After a lot of scrubbing he revealed the stone to be made from a single piece of pink granite. Stones of this color often came from quarries in Georgia.

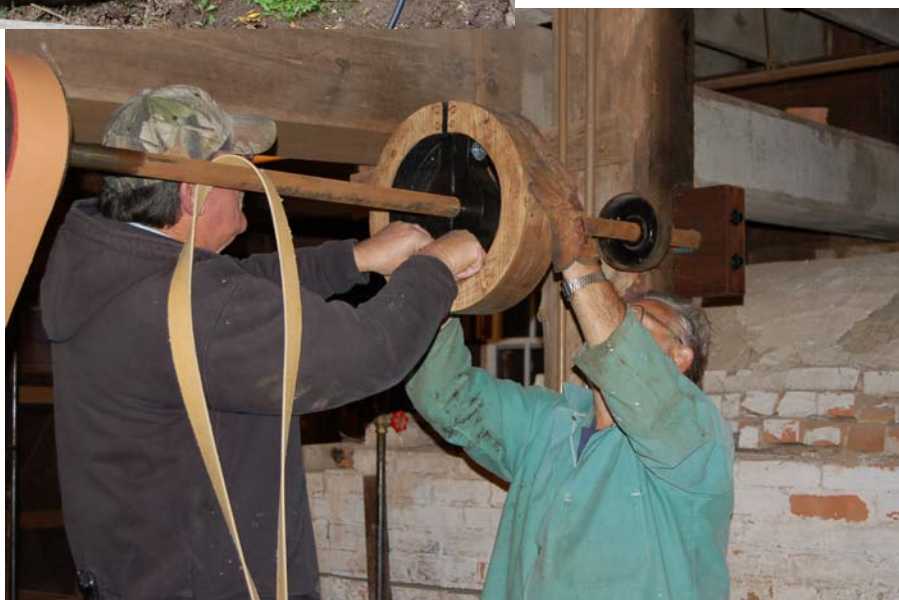
Peter Allenger and Scott Gibbs installing the new steam engine governor drive pulley that Scott built.

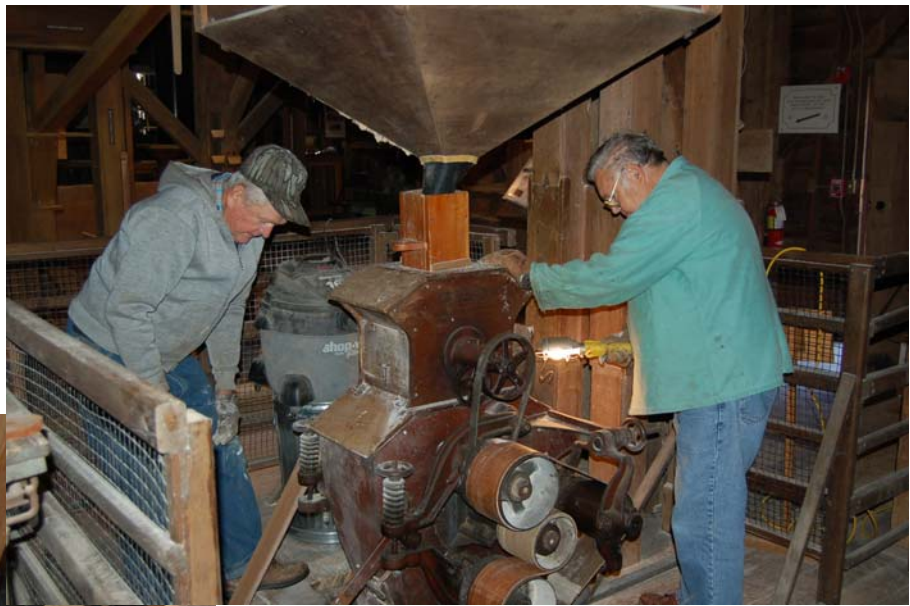
Joe Clark and Peter Allenger are unjamming our three roller corn mill. Once jammed it takes a careful cleaning to get it to run again.

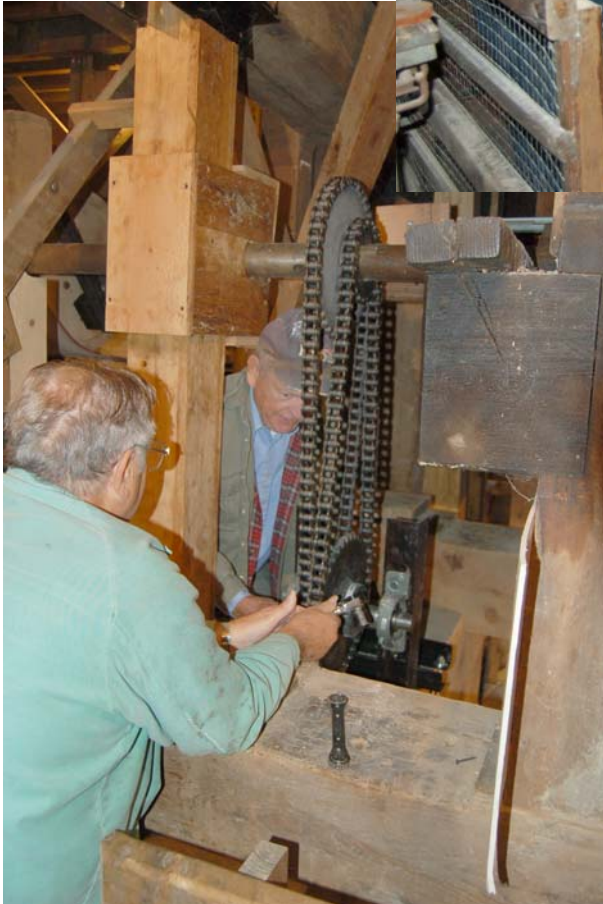
We are not shy about correcting mistakes that we have made in earlier restoration work. During testing of the steam engine belting we discovered that the lag bolts that hold the speed reduction jackshaft mount were pulling free. The cause of the problem is the large amount of torque on the drive chains when the mill's electric drive motor is started or stopped.

Here Joe and Peter are remounting the steam engine speed reducer jackshaft. You can see how the main line shaft has been split to accommodate the two 2:1 steps of speed reduction.

The solution was simple. All we needed to do it remount the jackshaft using bolts run through the 12" wood beam that it sat on. Once remounted the jackshaft has been stable.

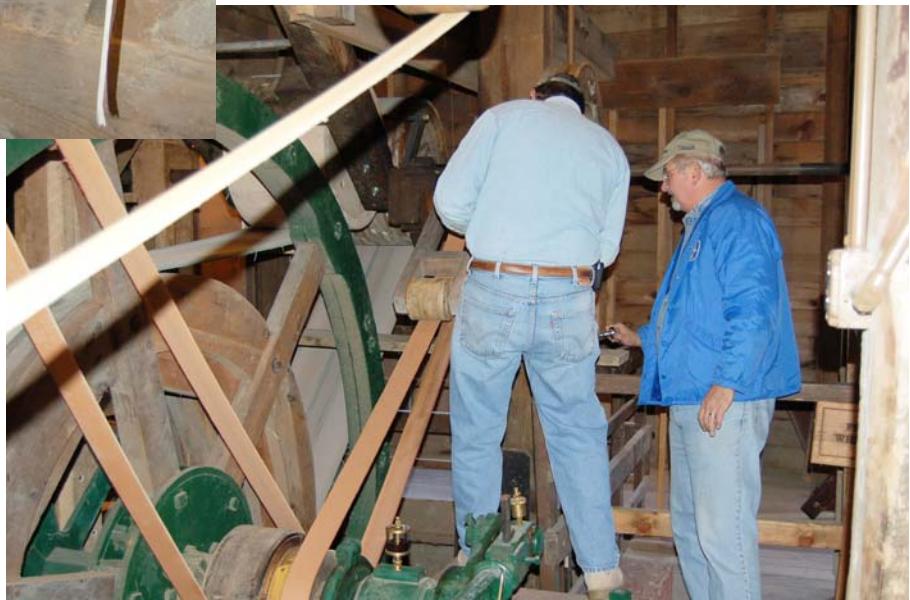
As usual the belt and pulleys fought us every inch of the way. The idler that we had used before did not work properly because of its location in relationship with the pump pulley. Scott Gibbs made a new mount for the idler that allowed us to position it correctly. Although the belts still would not track as perfectly as we wanted, results with the new idler mount were better. In the spring when work resumes we plan to modify the idler mount further to make the pump drive as trouble free as possible.

Scott Gibbs and Jerry Kieth installing the new idler mount for the water pump drive belt.
