# Friends of the Pine Creek Grist Mill

Wildcat Den State Park, Muscatine, Iowa

## Progress Report

Where we stand September 7, 2006

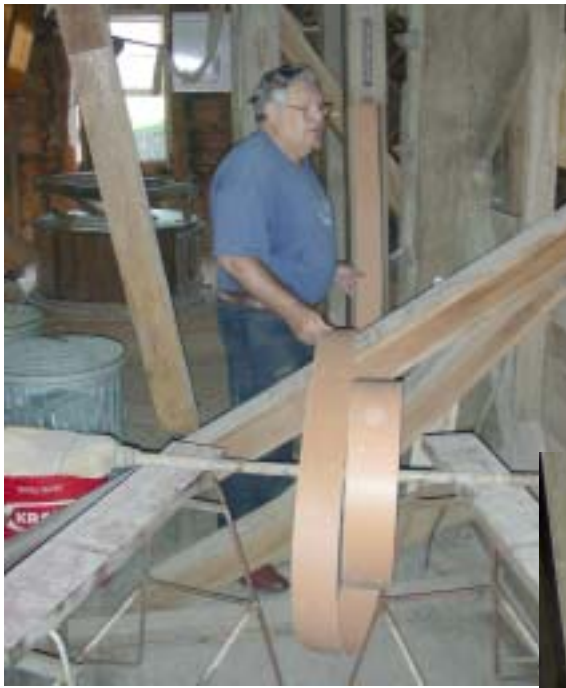
Peter Allenger is feeding the new belt into the south elevator. This is done by wrapping a long rope attached to the belt through the elevator and over its pulleys. Its a three man job to do this. The buckets are bolted on after the belt is in place and tightened.

Both the north and south slanting elevators are fully restored and operational. The north elevator required a new boot (the box at the base of the elevator) and as I have described before, all of the south elevator in the basement was completely missing. We finished up the south elevator, installed a belt and the buckets in it and it works well. We discovered that the head of the elevator, its cover and drive also had some old problems that we corrected.

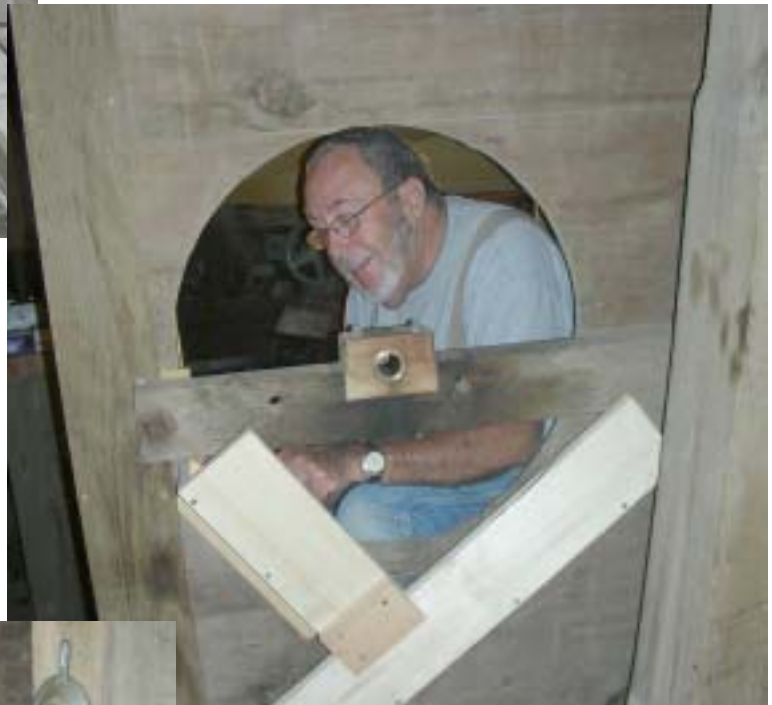
Yes, that's Bob Delong *inside* of the cottle collection bin! Bob had to climb inside (no easy task) to repair a rotted 2X4 brace. The cottle's rotating screen will take Bob's place after the machine's final assembly. The new boards in the "Y" shape collect any debris that tails-over the rotating screen.

It seems like we are always finding something new to repair on the cottle. Since last month we have replaced the rotted door that controls the flow of grain into the machine's revolving screen. We have also replaced the rotted (and mostly missing) chutes that collected any debris that tailed over the end of the screen. Inside of the cottle we worked on replacing some rotted boards and even patched a hole chewed in it by some critter. Currently we are working on the bin that collects the grain as it passes through the rotating screen.

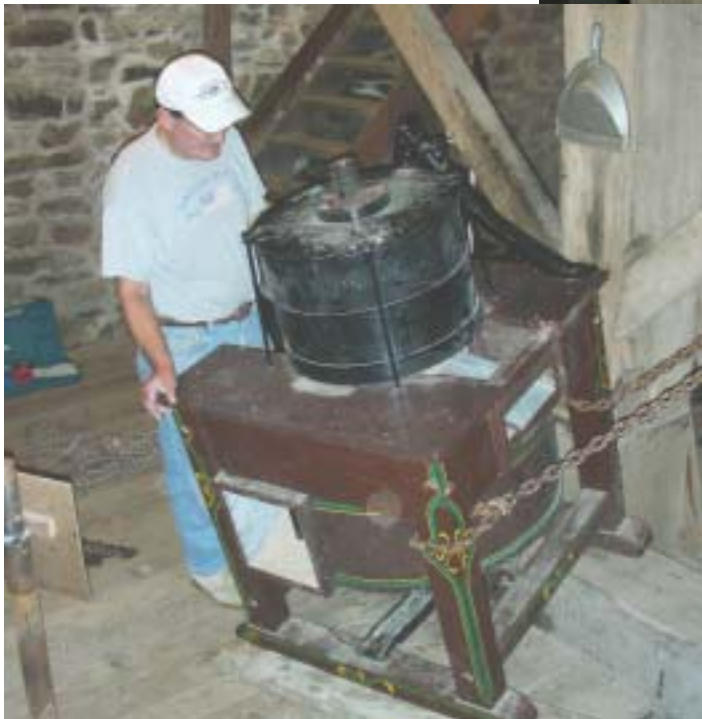
Here Scott Gibbs is steadying the smutter as it is being moved across the flywheel pit prior to its being hoisted back into its original location. The black cylinder on the top of the machine has paddles in it that beat the grain against the slots in the sides of the cylinder. This agitation helps to remove dirt from the grain. The cylinder cannot be seen once the machine is in place.

With the elevators finally working, we were finally able turn our attention to reinstalling the smutter. Some time ago Dick Clevenger restored the smutter for us (another one of those winter projects). The smutter cleans smutt (a black fungus), dirt and other debris from the buckwheat before it goes to the millstones. The machine does this by a combination of aspiration and agitation against a metal screen. Aspiration is widely used in the mill for cleaning grain. The process is quite simple and ingenious. The grain falls down vertically down a chute while a current of air passes upward in the opposite direction. The weight of the grain carries it downward while the lighter dust and debris is carried upward (and eventually out of the mill) by the air current.

What we have now is almost a new smutter. Like many of the mill's machines, it is largely built of wood and like so many items in the basement, it suffered badly from dry rot. Dick replaced all of the wood parts and the machine now looks like the day it came from the factory. At this writing we have it back in position hanging from the basement ceiling as it did originally. Getting the machine back into place proved to be a challenge to say the least. Once in place, we started bolting the rest of the machine together. This gave us a chance to consider how the machine worked again to make sure we were getting it back together correctly :-).

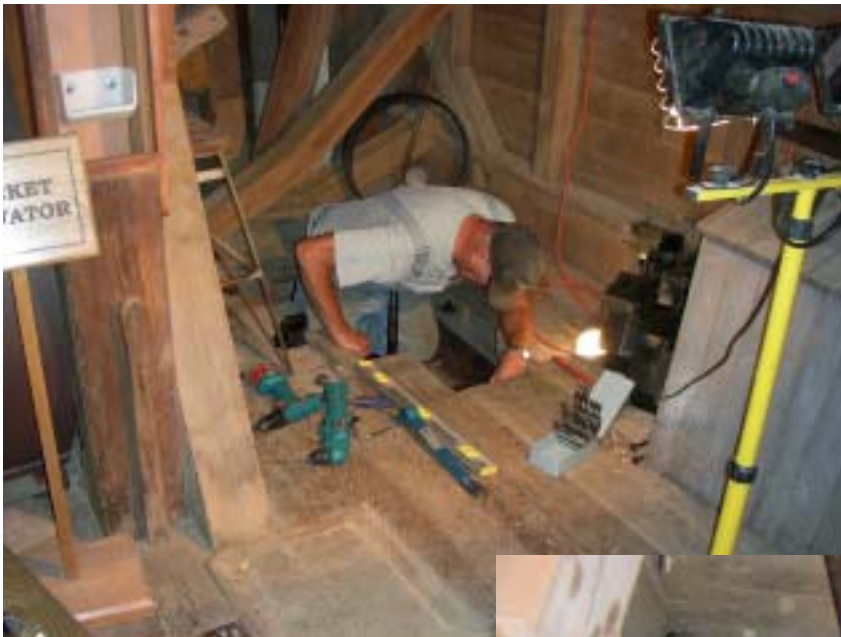
No, Dick Clevenger is not jumping through a hole in the floor. Actually he is standing on the top of the smutter while installing part of the agitator drum. The smutter hangs from the basement ceiling with part of it projecting up into the first floor.

Once the smutter installation is completed, we still have to reconnect it to its flat belt drive and build a chute to connect it to the elevator that carried the grain to the millstone feed bin on the second floor. The smutter has a unique drive arrangement that uses a friction drive. Pulling on a lever on the first floor shoves a lever that in turn presses a pulley on a jackshaft against a pulley on the top of the same second jackshaft that powers the millstones. Getting this strange drive arrangement working again will take the usual amount of reverse engineering that we on the restoration crew enjoy so much.

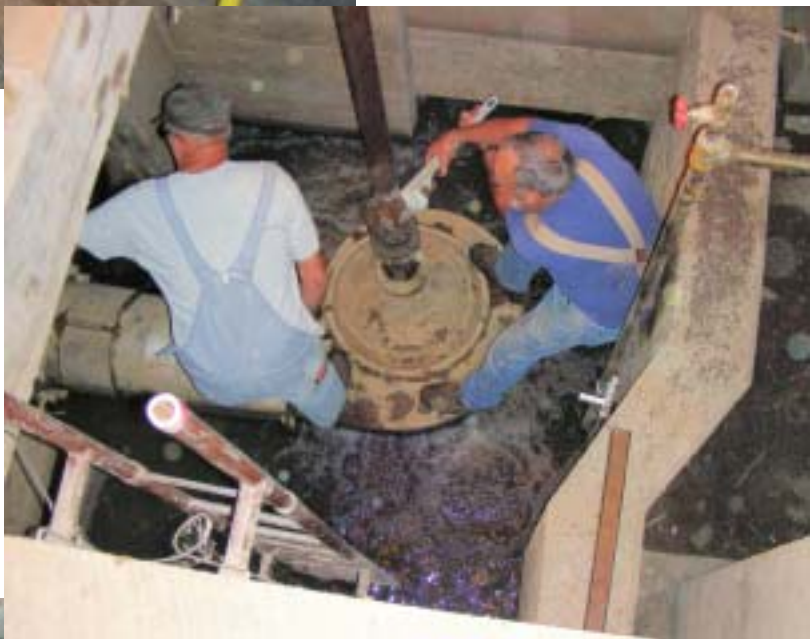
To get ready for Heritage Day Bob Delong and Dick Clevenger are clearing the turbine of mud and getting it turning again. This requires opening up the penstock gate and giving the turbine shaft a few turns with a large pipe wrench to get it moving again. Note the water boiling out from the bottom of the turbine.

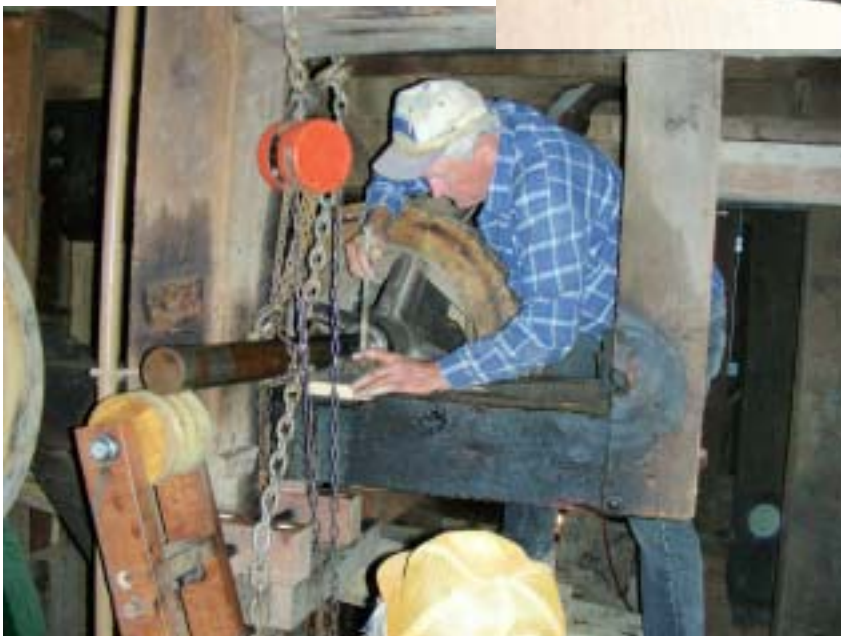
Joe Clark and Peter Allenger are shimming up the south end of the main line shaft in the basement. The hard wood block they are placing under the pillow block raised the shaft to level it.

We also discovered that settling of the building had warped the main line shaft in the basement. The south end of the shaft was 1.25" low at its pillow block. Joe Clark and Peter Allenger went over the alignment of the shaft very carefully and corrected the problem by installing a hard wood shim block under the pillow block. We tested the mill for twenty minutes after the shim had been installed and were pleased that there is less vibration in the system now since the shaft is no longer flexing.
